# Materials Matter™

## DUPONT PHOTOVOLTAIC SOLUTIONS

### The Importance of Selecting the Right Materials for Solar Modules

### Solar Installation Inspections in Europe and the Middle East

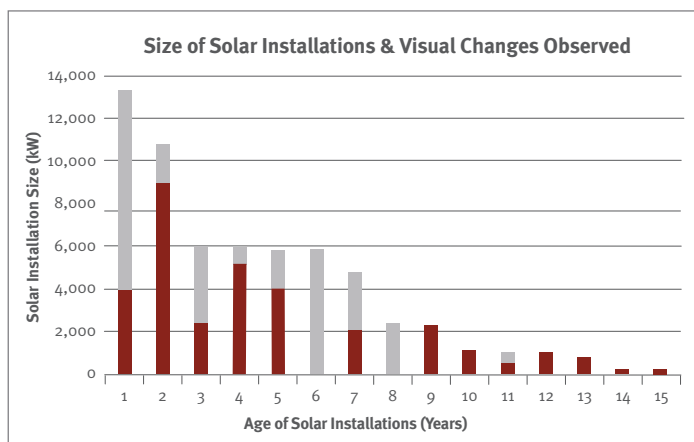
Figure 1. Solar installations in order of decreasing size showing the proportion of visual change in brown to the intact proportion in gray.

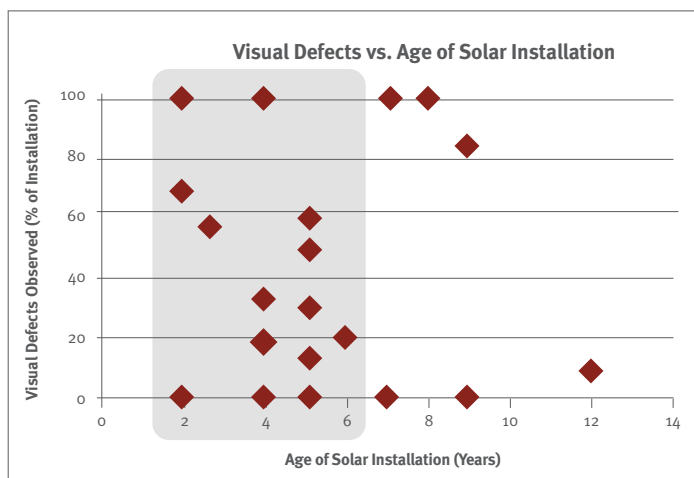
Although solar installations of all ages showed signs of visual defects, an alarming finding was that these defects are occurring on a large scale in relatively young modules with less than six years in the field, as shown in Figure 2. Current qualification testing is not finding these early degradations.

Figure 2. Age of the solar installations versus the percentage of the installation displaying visual defects. Note the large percentage of visual defects on modules with less than six years in service.

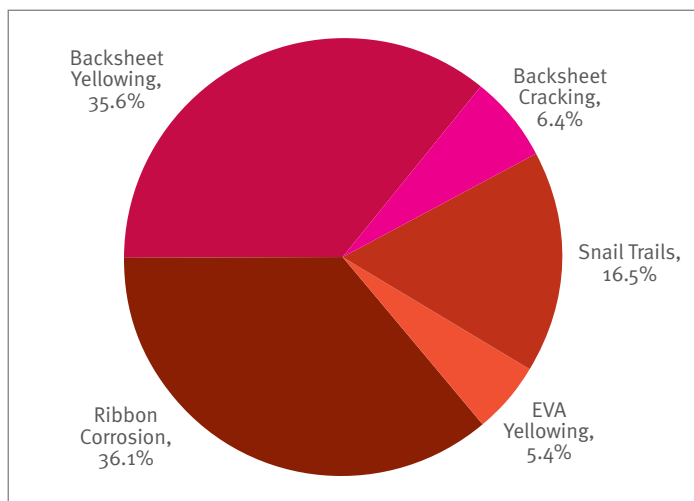
Figure 3 shows the percentage of each type of defect that was observed during visual inspections of the solar installations. Ribbon corrosion represents the largest visual defect observed (see Figure 4A). Ribbon corrosion is any change in color that was observed on the solder ribbons. This includes darkening of the ribbon surface, which can be due to darkening of ultraviolet (UV) sensitive flux residues, a change that would only impact the aesthetics of the module. However, it is important to note that in extreme cases, ribbon corrosion can lead to backsheet degradation by resistive heating, which will eventually affect the safety and power generation of the module.

Figure 3. Percentage of defects observed by type for all solar installations combined (61 MW).

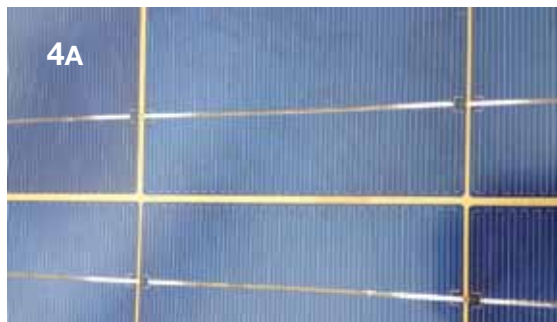
It is important to highlight that not all yellowing occurs on the backside of the modules. Frontside yellowing of the backsheet is caused by a degradation of the polymer used to promote the adhesion of the specific backsheet to the encapsulant. In addition to showing ribbon corrosion, Figure 4A shows an example of frontside yellowing of a PVDF-based backsheet after only five years in a field in Spain. This type of frontside yellowing has been reported as occurring within 6 months of installation.

4A An example of ribbon corrosion, as well as frontside yellowing of PVDF-based backsheet after five years (Spain).

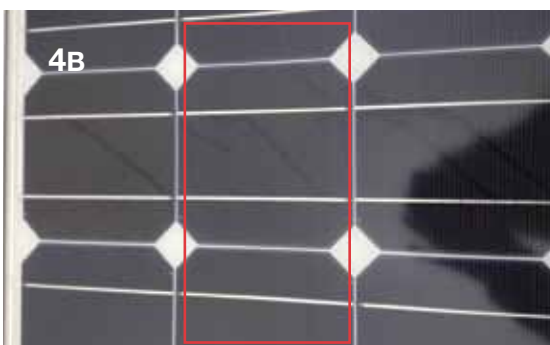
An example of snail trails, which are a discoloration of the fine conductor lines overlaying a crack or micro-crack in the cell, is shown in Figure 4B. This is believed to be a fairly recent problem (approximately six years old), resulting from the interaction of EVA encapsulant additives and silver.

Snail trails can be an early indication of future issues. For example, thermal cycling can eventually enlarge the cracks and separate the fine line connections, resulting in power loss. The questions that remain are: when will this occur and what will the impact be on power loss and hot spots?

4B An example of snail trails that affected 50% of modules in a four-year-old system (Spain).

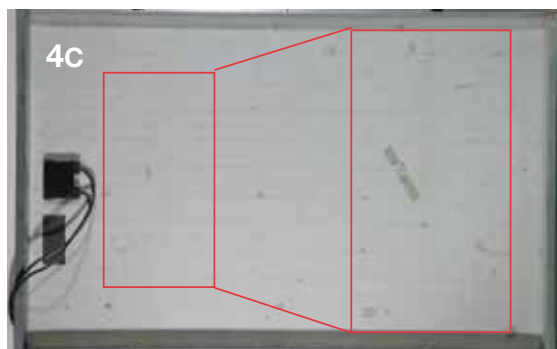
The defects of the most concern for backsheets include cracking, yellowing and delamination. Figure 4C shows an example of backsheet cracking and delamination on a polyester-based backsheet in Spain. This particular field had two different models of modules, with 100% of one model showing degradation after only four years in service.

4C Backsheet cracking in a polyester-based backsheet after only four years (Spain).

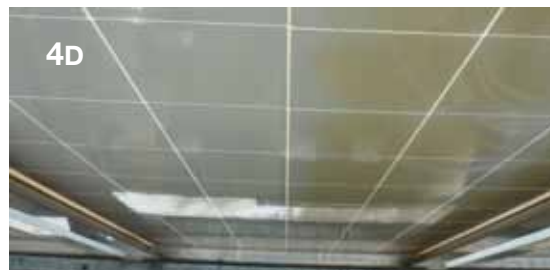
Day-night thermal cycles on a brittle backsheet can lead to cracking and/or delamination, resulting in loss of electrical protection of the module. Figure 4D shows a polyester-based backsheet displaying severe yellowing due to environmental stresses (UV, thermal, etc.) after nine years in the field.

4D Polyester-based backsheet yellowing after nine years (Italy).
