[Section 1 – Site Information]

[Section 2 – Claim Summary]

[Section 3 – Claim Details]

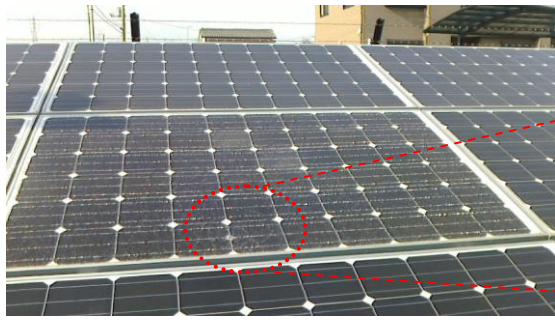
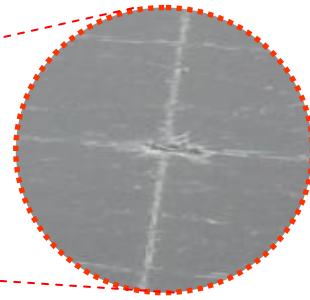
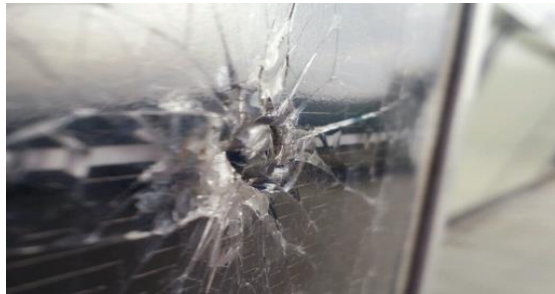
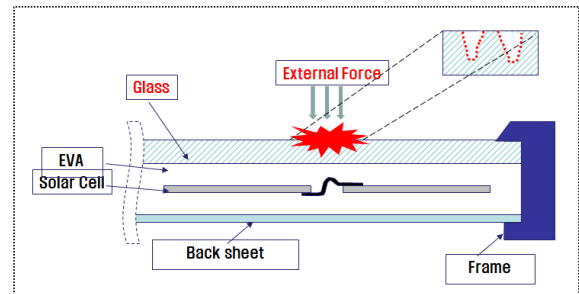
[CASE 1: Shattered glass by external force to the glass]

☞ The damaged point from external force can be found onto the glass.

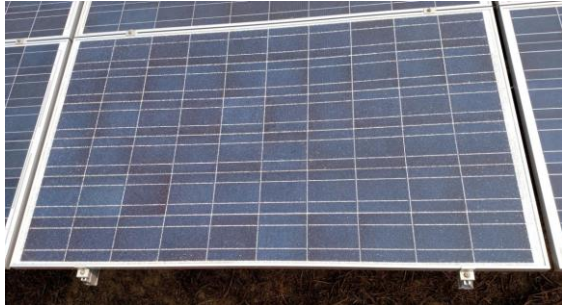
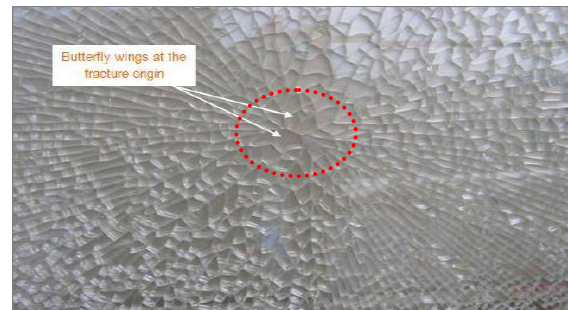
[CASE 2: Spontaneous shattered glass]

☞ No obvious impact point detected

☞ Butterfly wings can be found as the origin of shattered glass

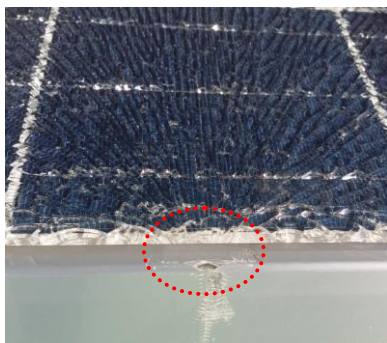
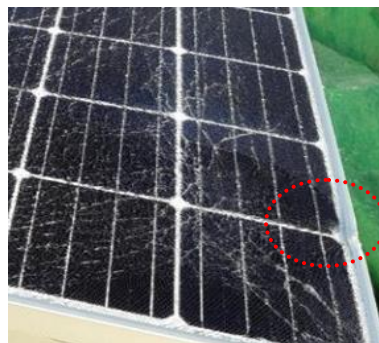
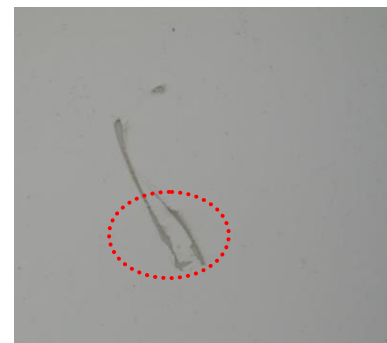
[CASE 3: Shattered glass with deformation of other parts by external force(mostly poor handling)]

☞ The damaged point from external force to the frame can be found

☞ The damaged point from external force to the back sheet can be found.

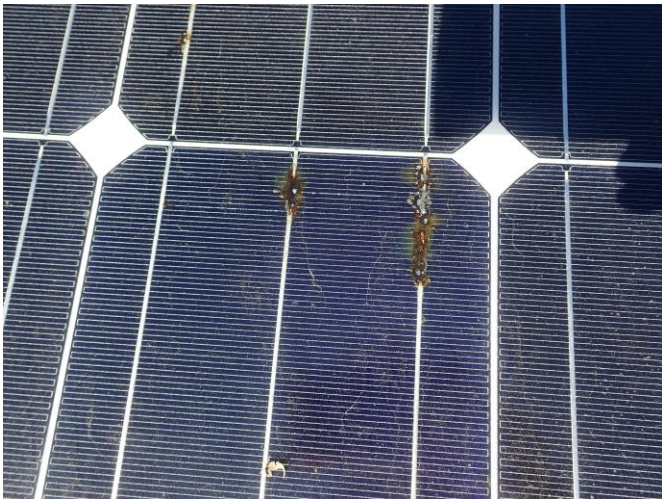
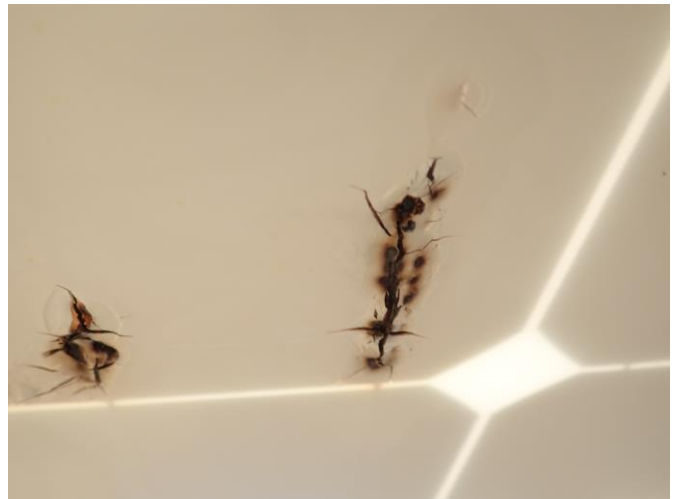
[BURNT EXAMPLE 1: Cold solder joint between cell and ribbon]

- ☞ Burnt marks are following the cell electrodes. If there is scar on the back side or impact point on the front, it was occurred by external force.

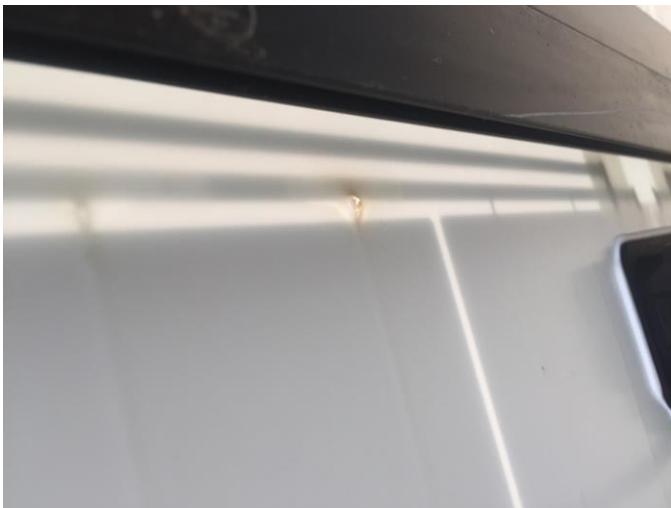
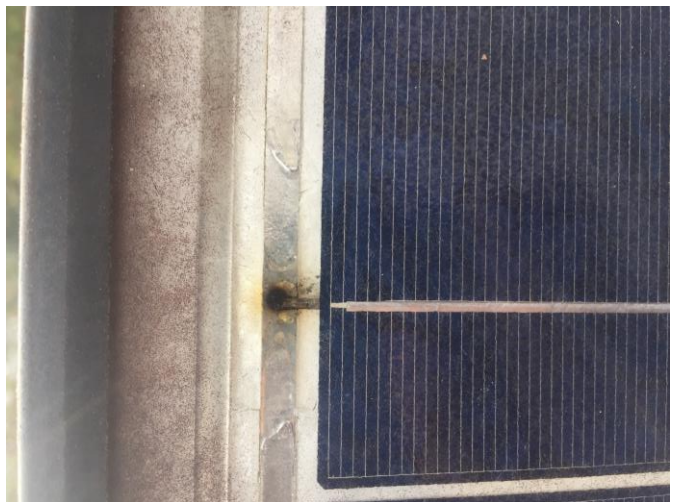
[BURNT EXAMPLE 2: Soldering defect between inter-ribbon and bus-ribbon]

- ☞ You could check this mark near the top & bottom frame.

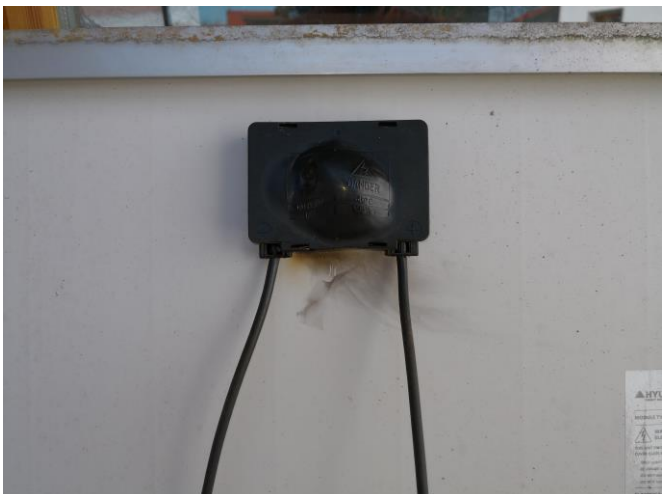
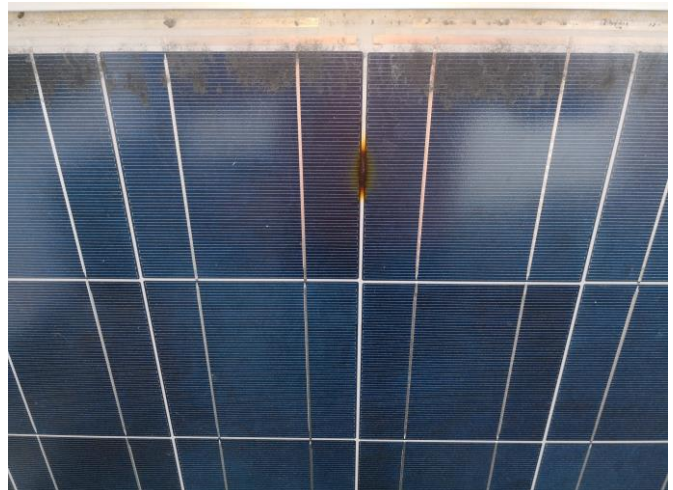
[BURNT EXAMPLE 3: Junction box (bypass diode) defect]

- ☞ Bypass diode defect is showing the inflated and burnt junction box.
