DuPont[™] Tedlar® Backsheet Introduction July 2017

THE DUPONT PORTFOLIO OF INNOVATIVE MATERIALS FOR SOLAR MODULES

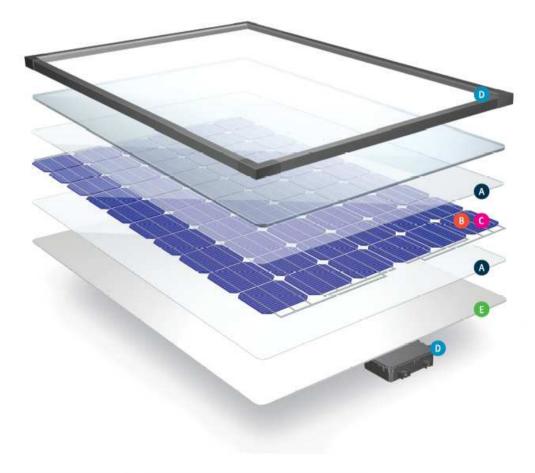
CRYSTALLINE SILICON MODULE

DuPont* Solamet* photovoltaic metallizations

SILICON DOPING TECHNOLOGIES
 DuPont[®] Innovalight[®] silicon inks

D ELECTRICAL AND STRUCTURAL COMPONENT MATERIALS DuPont[®] Rynite[®] PET thermoplastic polyester resins DuPont[®] Crastin[®] PBT polybutylene terephthalate resins

BACKSHEET MATERIALS DuPont Tedlar' PVF films

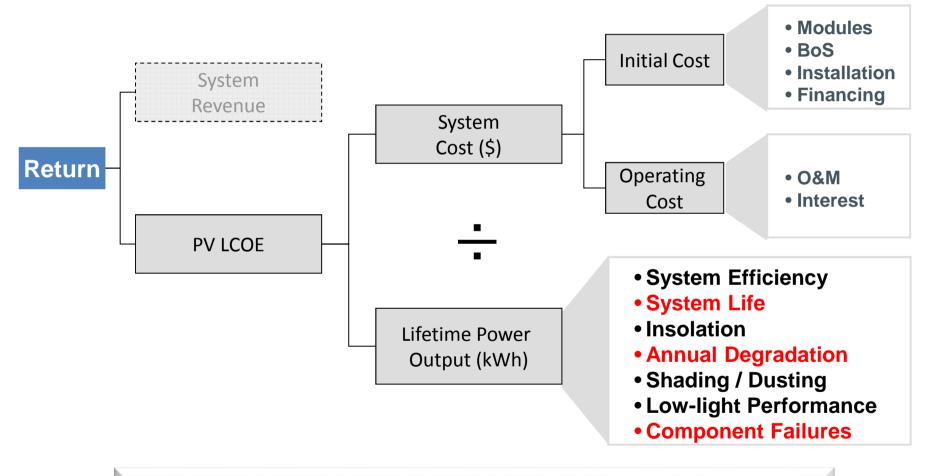
Our Goal is to Lowre Levelized Cost of Energy (LCOE)

Reducing system lifetime by 5 years can increase the LCOE by ~30% This is equivalent to an increase in system costs of ~ 35%

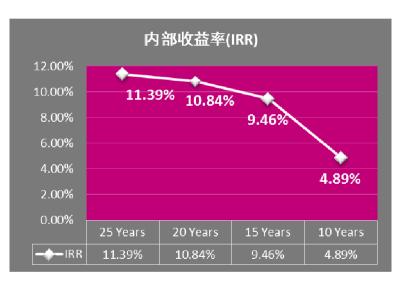
IRR vs Lifetime

Annual Power Degradation = 0.8%

20MW Solar Farm in West China

- > Annual Full Utilization Time: 1650 hours
- > FIT: 0.90 RMB/kWh (Class 1 Region)
- System Cost: 9 RMB/kWh

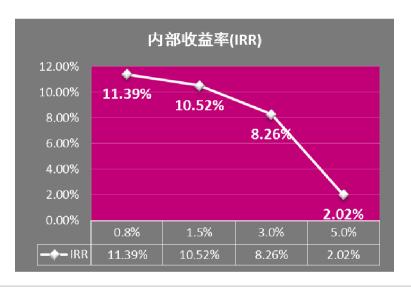
IRR vs Annual Power Degradation

Lifetime = 25 years

- Loan Ratio: 70%
- Interest Rate: 7%
- Discount Rate: 8%

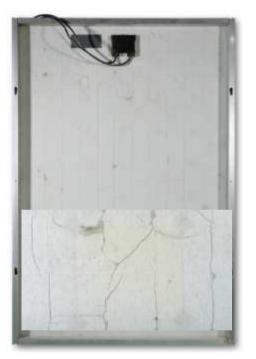
Backsheet Type: PET

- 5 years old installation in Spain
- Yellowing and Cracking
- 32% power loss over 5 years (6.4%/year)
- Some modules failed wet leakage test – Safety Risks

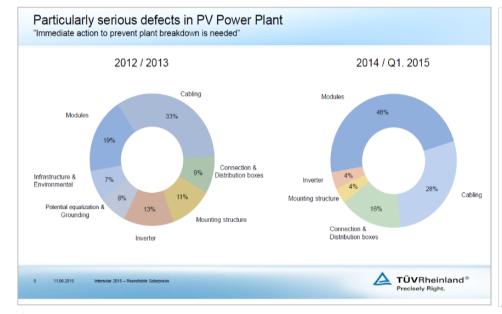
TUV Rheinland 2015 Data

PV module defects increased from 19% in 2013 to 48%

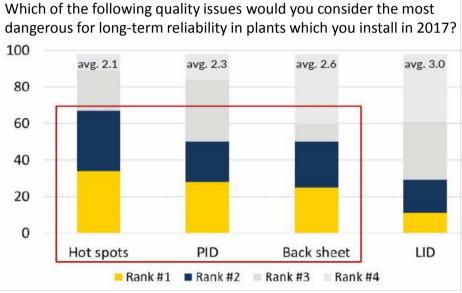
PV Magazine 2017 Quality Survey

Backsheet is among top 3 quality issues

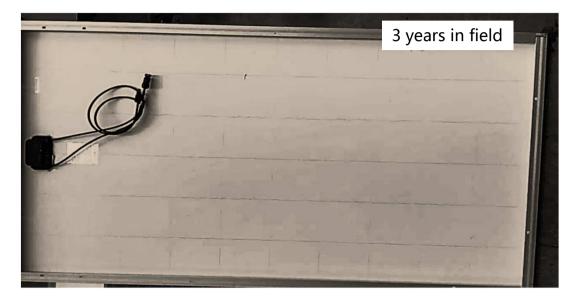
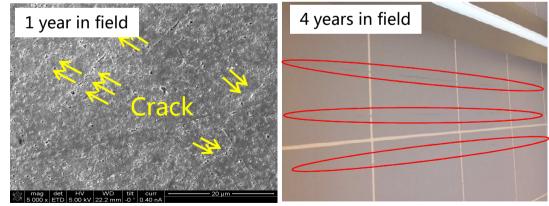
GW Level Field Module Failure due to Backsheet Cracking

- Installed in 2012, inspected in 2015
- Backsheet cracking and delamination and corrosion as water ingression

- Solar farm installed in 2012
- Micro-cracks on backsheet found in 2013
- Cracks of backsheet found in 2016

- 100MW fishpond application, installed in 2013
- Around 10% less power generation than expected in 2nd year in field
- 49.4% power degradation of sample module as PID
- Backsheet cracking

The quality issue were not discovered by IEC qualification tests and extended IEC tests

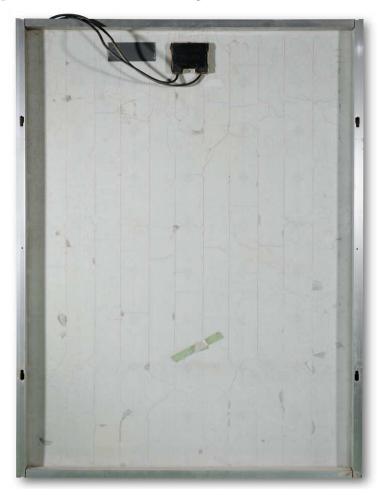
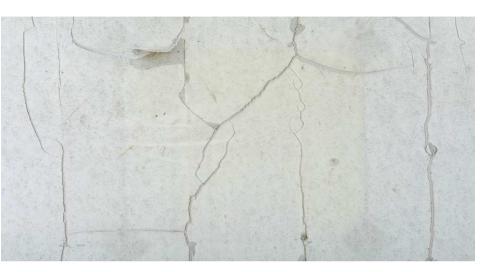
Spain 2.3MW Polyester-Based Backsheets-Severe Cracking After 4 Years

- 4 years old, 2.3 MW field located in Spain with two module types
- Based on sample observation, all polyester-based backsheets in this field showed cracking along the busbar ribbons
- Some modules failed wet leakage testing
- Owner could not obtain replacement panels

Cracking can lead to module failure and a safety hazard

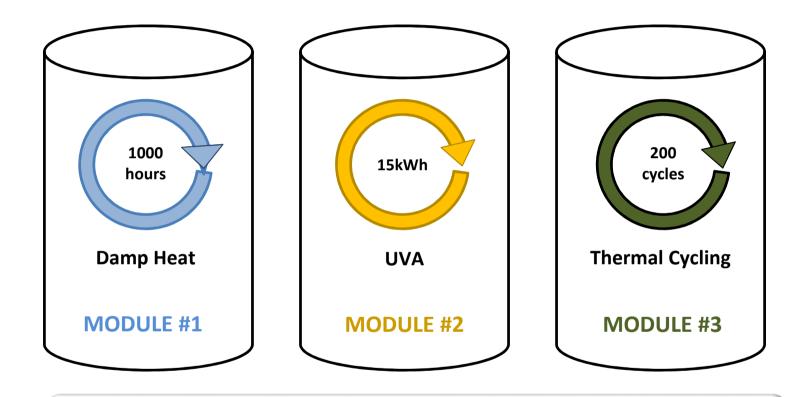
Root Cause 1: Current IEC Testing Method- Single Aging Stress Tests

Current lab testing standards are <u>not</u> rigorous enough to predict the durability of protective materials.

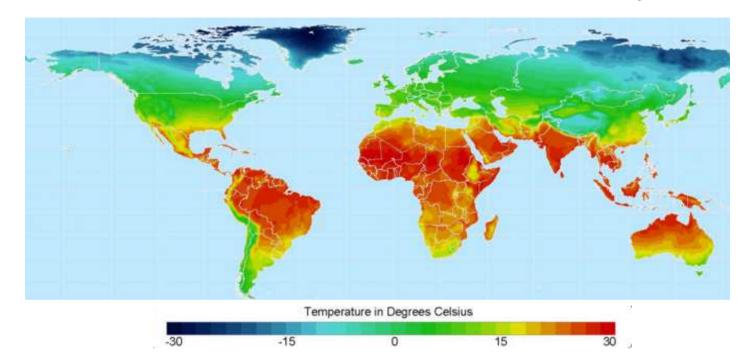
Root Cause 2: Insufficient UV doses and Thermal Cycles

DESERT	TROPICAL	TEMPERATE
Annual UV (kWh/m2) (source: Atlas)	92	79	57
25 Year UV Exposure to Back of Module @12% albedo (kWh/m²)	275	235	171
IEC	15kWh/m2 pre-conditioning, can lead to no exposure on backsheet		
UVA Exposure Level to Simulate 25 Years (hrs)	4230	3630	2630

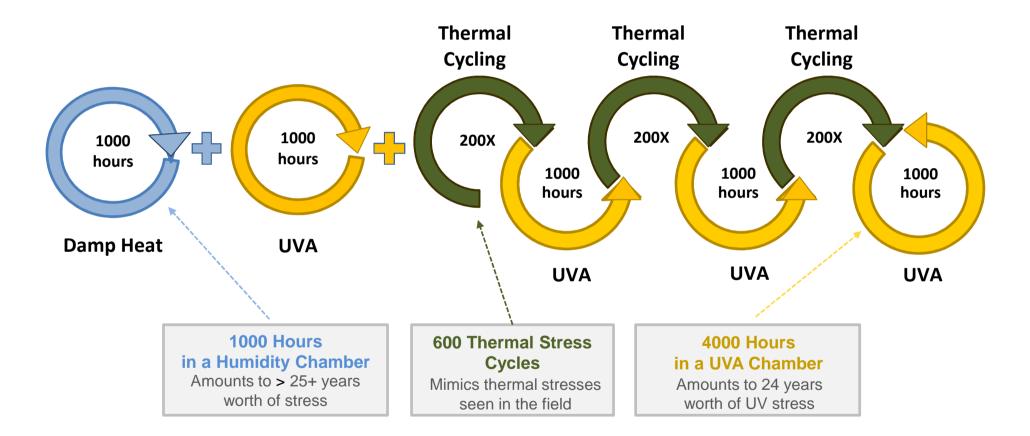
The Solution: Module Accelerated Sequential Testing (MAST)

Repeated sequential stress mimics field degradation not detected by single tests and current industry standards

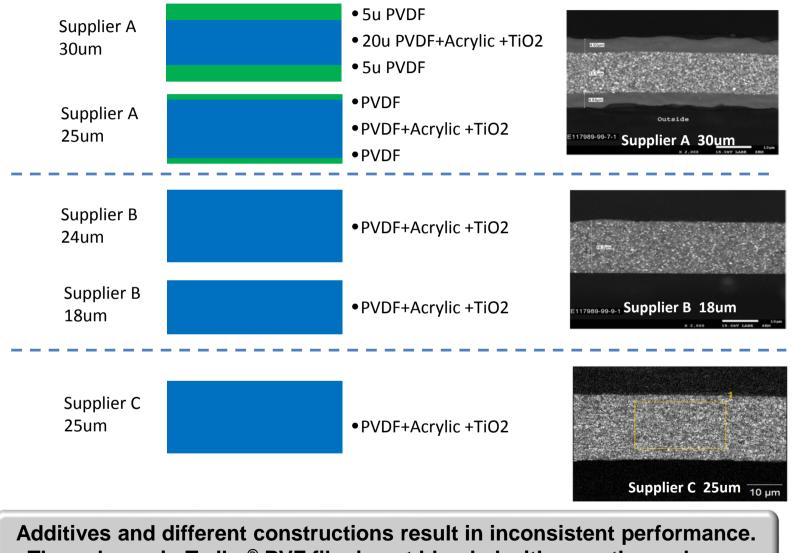
PVDF film suppliers have different constructions and additives

The polymer in Tedlar[®] PVF film is not blended with any other polymer.

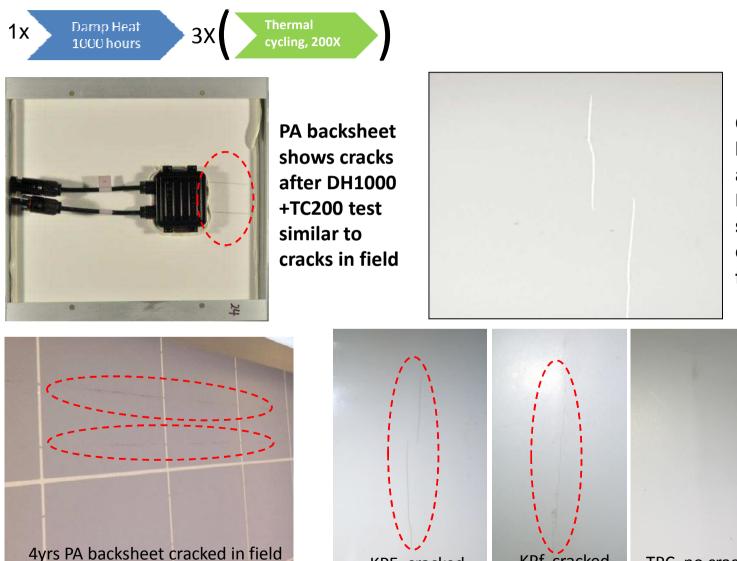
Sequential Aging Test Shows Consistent Results with Field Failures

Cracks in 1s PVDF backsheet (KPf) after DH1000+TC400 similar to cracks observed in the field

> Cracks in KPE and KPf along ribbon wires after TC600 similar to cracks observed in the field

KPE, cracked

KPf, cracked

TPC, no crack

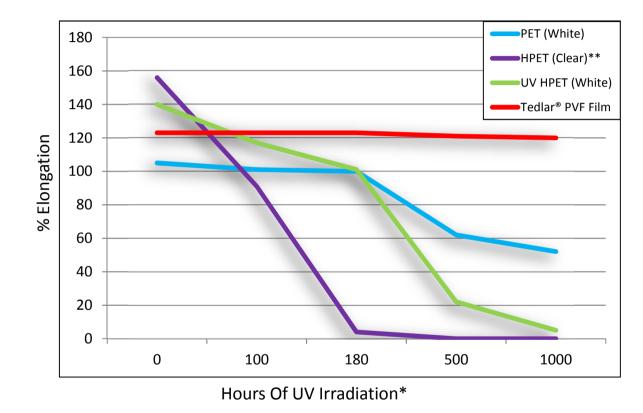
Tedlar® Film Provides Superior Protection From The Sun's Radiation Effect On Mechanical Properties vs. PET Film

PET films are inherently not a good choice for backsheet protection; they will loose their mechanical properties and degrade quickly.

*Irradiation: 120 W/m², 300-400nm, 103°C BPT, 50%RH

** HPET=Hydrolysis resistant PET

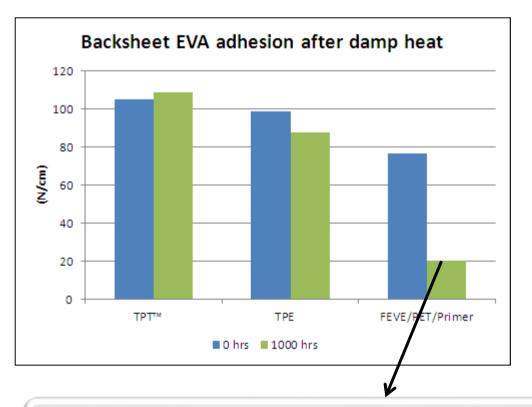
FEVE-Based Backsheets Losing Adhesion After 1000h Damp Heat, Many User Reports of Issues

- Embrittlement, cracking & flaking observed in fielded module backsheets
- E-Layer cracking after airside Xenon exposure
- Multiple users report that FEVE coatings are easily scratched and have low abrasion resistance
- Multiple user reports of low adhesion to the j-box
- Users report poor EVA adhesion and delamination issues in the field
- FEVE-based backsheet lost over 70% of adhesion after damp heat exposure
- Loss of adhesion indicates a higher risk of delamination
- Cracked tie layers can lead to tearing, cracking and delamination in the field

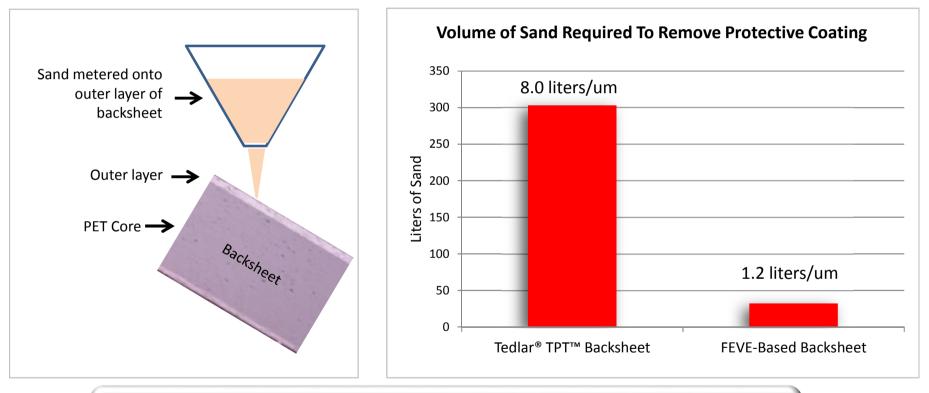
FEVE-Based backsheets Underperform Tedlar[®]-Based Backsheets in Sand Abrasion Test

Severe abrasion or deep scratching can compromise the backsheet, risking safety and module failure
